PinkWood PKI® Joists Minor Flange Cuts – Canada (LSD)

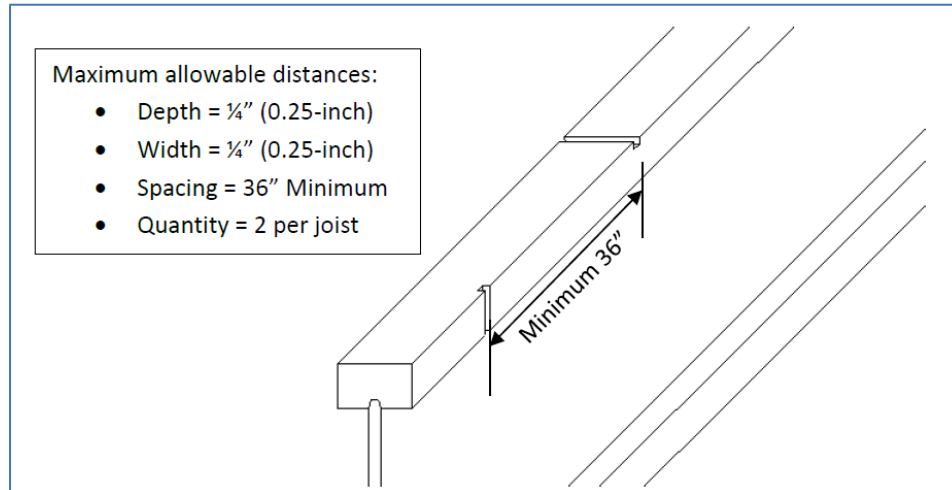
Minor flange cuts:

When handling, cutting, and packaging PKI® I-Joists, it is common for small cuts to be mistakenly made into the joist flanges. These cuts could be the result of a chainsaw blade bump, or a skill-saw with the depth guard improperly set. While these small cuts are not desired, they do not affect the structural performance of the joist provided the cuts fall within the following limitations:

Note: If minor flange cuts or banding/wrapping damage exceed those listed above, a review by a licensed design professional may be required.

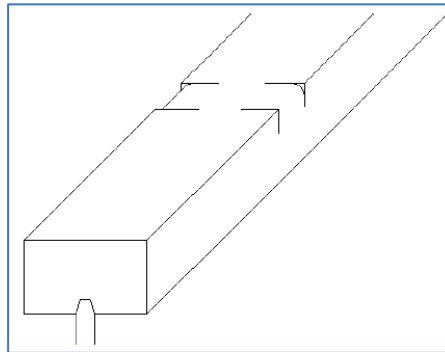
Banding/wrapping damage:

Localized crushing damage can occur when the band of the wrapped I-Joists is cinched too tightly around the I-joists. This is more obvious when the joists have been exposed to wet weather conditions prior to or during the wrapping process. The appearance of banding marks and flange distortions, as seen below, does not affect the structural performance of the joists if the band cuts do not exceed $\frac{1}{3}$ of the flange depth and the total length of the cuts at the same location on the face of the flange does not exceed $\frac{1}{2}$ of the flange width.
