Pinkwood PKjoists®

Minor Flange Cuts and Banding Damage

TECHNICAL BULLETIN
TB06

January 2020 (Expires 1/1/2022)

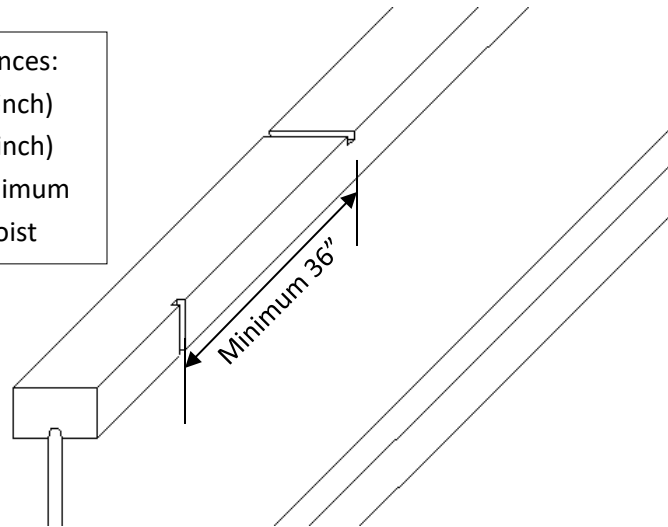
Minor flange cuts

When handling, cutting and packaging PKjoists®, it is common for small cuts to be mistakenly made to the joist flanges. These cuts can be as the result of a chainsaw blade bump to the top of the joist pack or a skill-saw cut with the depth guard improperly set. While these small cuts are unsightly, they do not affect the performance of the joist provided they fall within the following limitations:

Maximum allowable distances:

- Depth = ¼" (0.25-inch)
- Width = ¼" (0.25-inch)
- Spacing = 36" Minimum
- Quantity = 2 per joist

Note: If minor flange cuts or banding damage exceed those listed above, a review from a licensed design professional may be required.

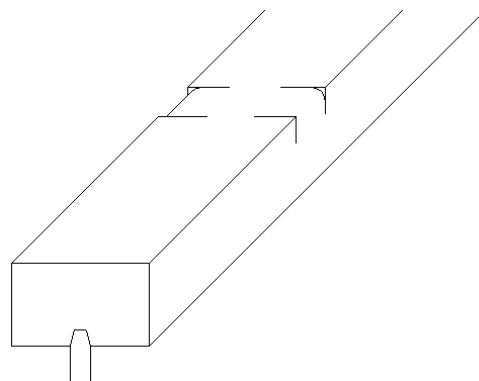
Banding damage

Crushing damage can occur when joist pack banding is cinched too tightly around the I-joist. This is particularly true when the joist has been exposed to wet weather conditions prior to or during the banding process. The appearance of banding marks and flange distortions, as seen below, does not affect the performance of the joist.
