# Pinkwood PKjoists®

## Standard Top Flange Notch Repair

## TECHNICAL BULLETIN

TB11

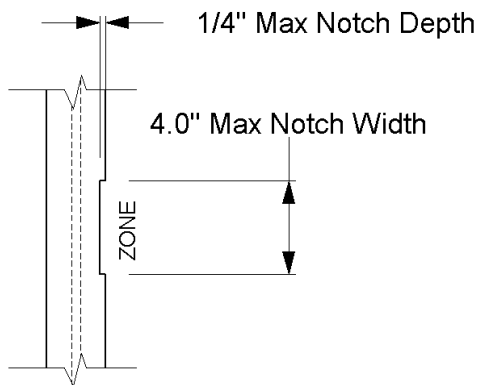
### Notch Dimensions

While it is common for subfloor penetrations to occur close to joist locations, it is recommended, when possible, to shift the joist away from such penetration to avoid inadvertent cutting the joist top flange. (see **TB02 On-Center shift allowance for plumbing**) When this is not possible, or when the joist shift was missed during construction, minor top flange notches on uniformly loaded joists can be repaired in a standardized method provided the location, size and length of these notches are as indicated below.

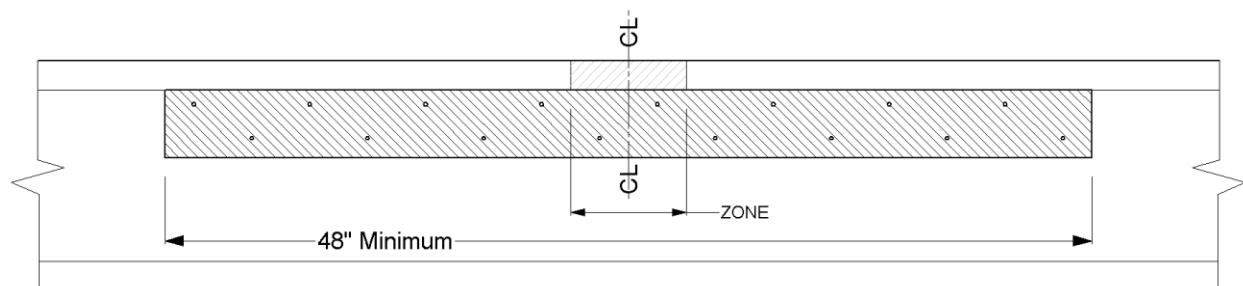
### Repair Location

OPPOSITE SIDE OF NOTCH

1. Use minimum 2x4 #2 Grade or better.
2. Apply construction adhesive to entire contact surface of reinforcement.
3. Install reinforcement tight to the underside of the top flange opposite the side of the notch.
4. Attach with min 10d common, 2 rows, staggered and clinched @ 6" o.c. or #8 wood screws.
