# Pinkwood PKjoists®

## Web Repair with Services Remaining

### I-joist web repair for holes

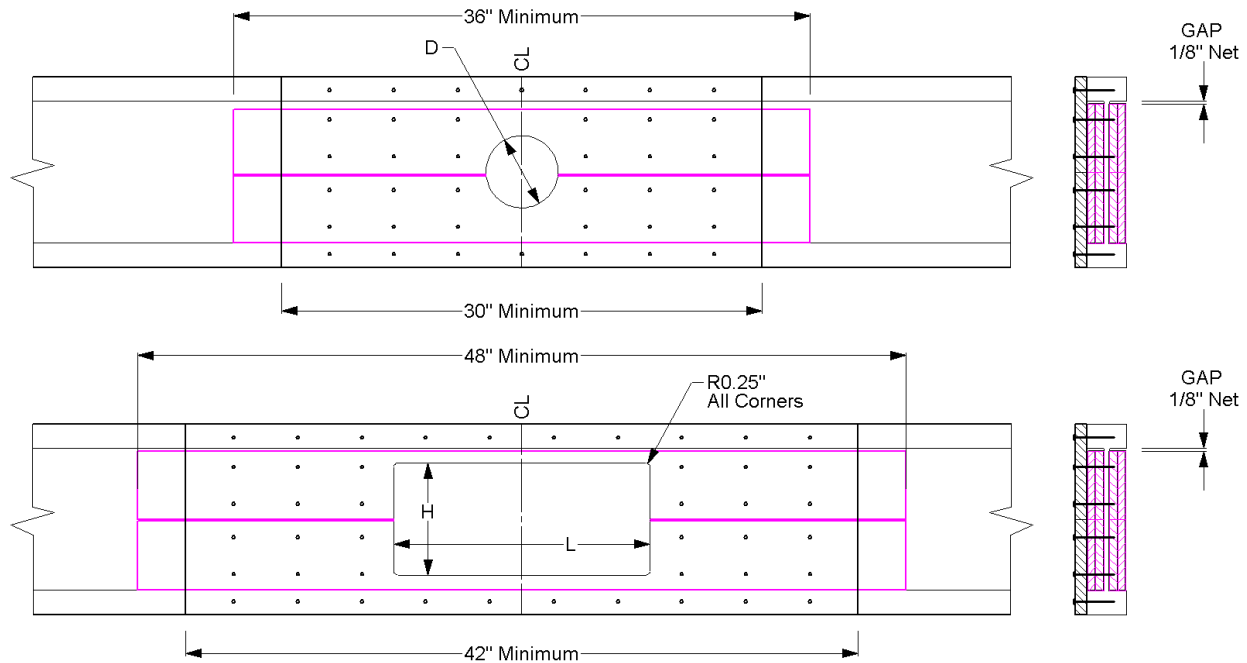
When holes are cut in the wrong location through the web of a PKjoist®, it is recommended to remove the service item and patch the hole per **TB12 "Standard Web Repair"**. When this is not practical and the penetrating item must remain as placed, the following detail can be used to restore the joist allowable shear with the following hole size and location restrictions.

1. Fill web with rated sheathing flush to outside of flanges, both sides, cut tightly around hole.
2. Apply construction adhesive to all contact surfaces of panel pieces.
3. Apply second layer of 23/32" rated panel, one side, cut tightly around hole.
4. Apply construction adhesive to entire backside and top edge of panel.
5. Secure to flanges and base layer with 8d nails x 2.5" long, 6 rows at 4" o.c.
