Pinkwood PKjoists®

Minor Flange Splits at Bearing

TECHNICAL BULLETIN
TB25

April 2021 (Expires 1/1/2023)

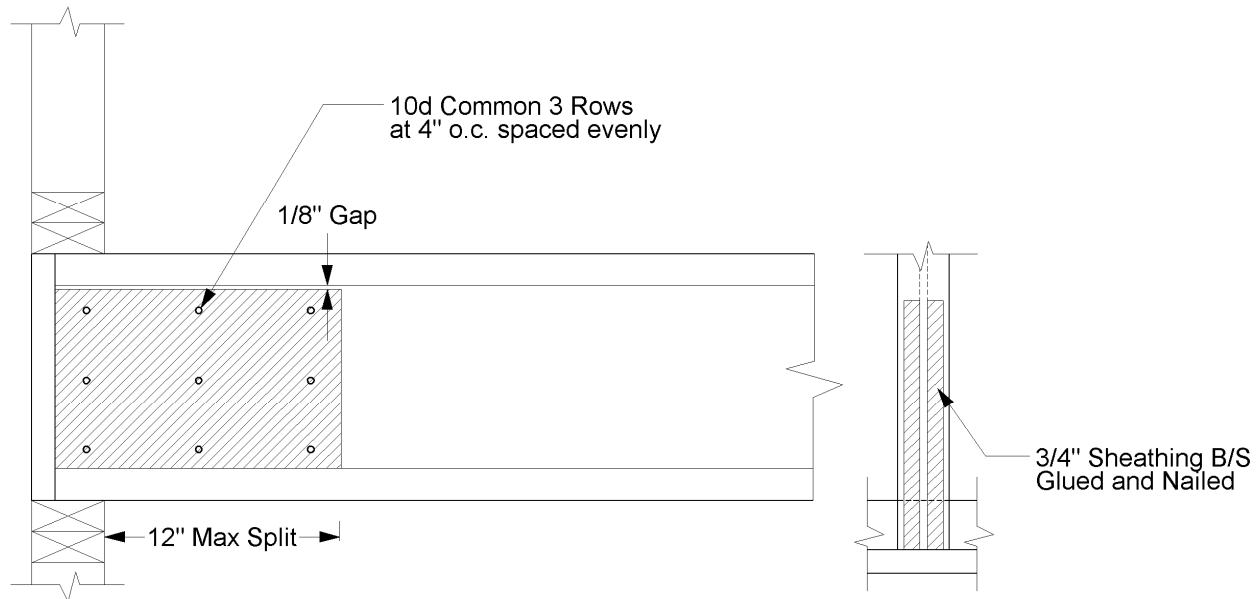
Minor flange splits

When installing PKjoists®, it is common for small splits to occur in the bottom flange at the bearing location. This is often due to toenails intersecting each other when the bottom flange is secured to the plate. To eliminate excessive reaction forces at the joist web, stiffeners can be used to widen the reaction area.

1. End Bearing Split cannot exceed 12" in length beyond the inside face of bearing.
2. The split cannot exceed 0.25" (1/4") in width.
3. The effected joist does NOT require a web stiffener under normal conditions.
4. Sheathing can be either OSB or CDX plywood.
5. Installed stiffener must be a minimum 16" long and flush to the end of the joist.
6. Use subfloor adhesive between stiffener and joist web.

Note: If minor flange splits exceed those listed above, a review from a licensed design professional may be required.
