Pinkwood PKjoists®

Minor Bottom Flange Splits at Mid-Span

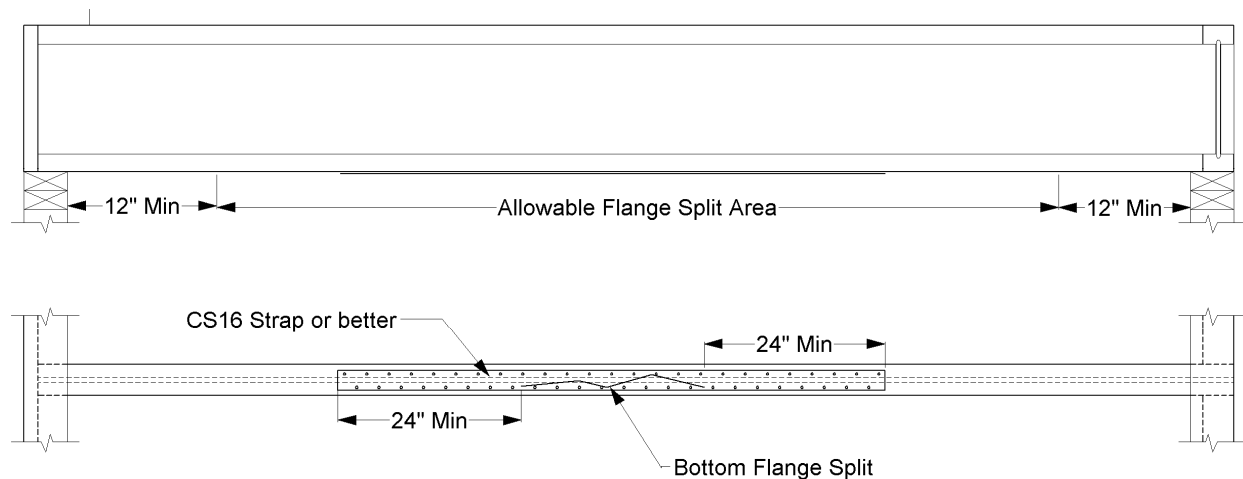
Minor bottom flange splits

When handling and storing PKjoists®, it is common for small splits and checks to occur in the solid sawn flange material. This is often due to additional drying of the flange material after manufacturing. When minor splits occur in the top flange, subfloor adhesive and fastener connections are sufficient remedy the condition. When minor splits occur in the bottom flange, a standard construction strap is sufficient to transfer the tension past the minor split and into unaffected sections of the flange. When needed, construction strapping should be installed as listed below.

1. Bottom Flange Split cannot exceed 24" in length.
2. The split cannot exceed 0.25" (1/4") in width.
3. The Tension strap must extend 24" beyond the end of the split on both ends.
4. Use 8d nails to attach the Tension strap and fill all holes.
