## PinkWood PKI<sup>®</sup> Joists Standard Top Flange Notch Repair – Canada (LSD)

### Top Flange Notch Repair:

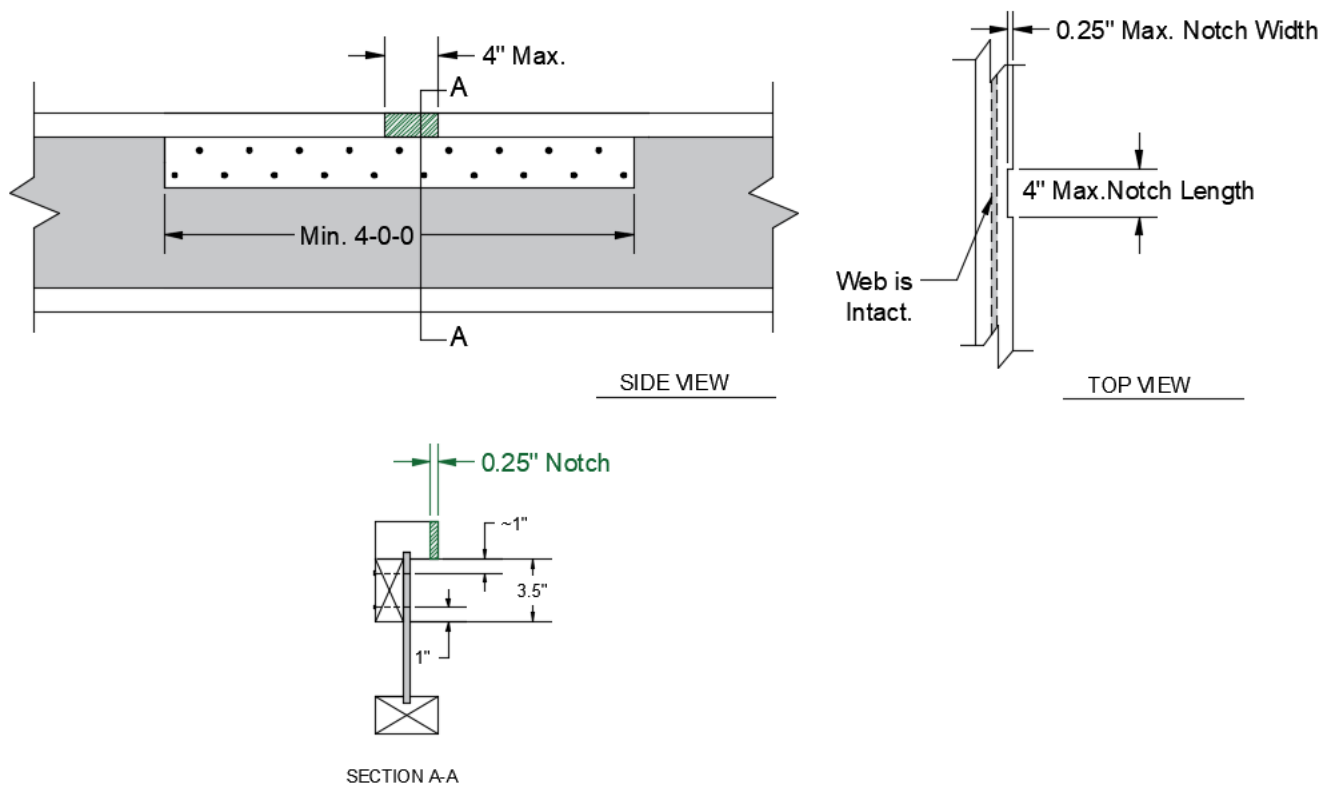
While it is common for subfloor penetrations to occur close to joists location, it is recommended, when possible, to shift the joist away from such penetrations to avoid inadvertently cutting the joist top flange (*see On-Center shift allowance for plumbing*). When this is not possible, or when the joist shift was missed during construction, minor top flange notches for uniformly loaded joists can be repaired in a standardized method provided the location, size and length of these notches are as indicated below.

- Install 2x4 #2 SPF or better grade reinforcement (centered at the notch location).
- Apply construction adhesive to all contact surfaces.
- Install reinforcement tight to the underside of the top flange opposite the side of the notch.
- Fasten reinforcement to the web with 2 rows of 10d Common Nails (0.145" x 3"), staggered and clinched @ 6" o.c., or with 2 rows of #8 wood screws at 6" o.c.
- Repair is only valid for uniformly loaded joists.
- Max. notch length = 4"
