Pinkwood PKjoists®

Top Flange Notch Repair for Plumbing

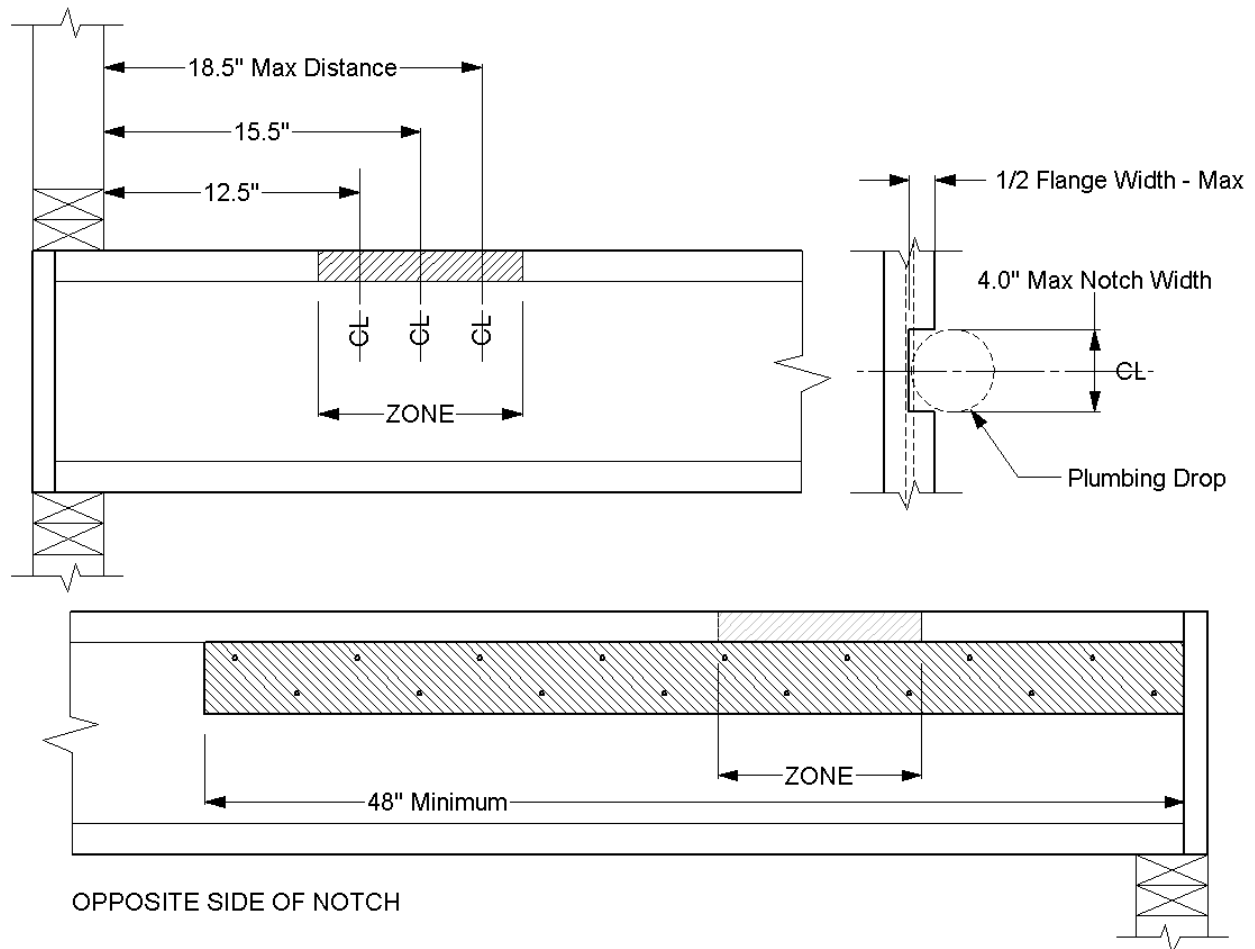
Flange notch repair

While it is common for drops to occur close to joist locations, when possible, shift the joist away from such drops to avoid inadvertent cutting with the joist top flange. (see **TB02 On-Center shift allowance for plumbing**) When this is not possible, or when the joist shift was missed during construction, top flange notches on uniformly loaded joists can be repaired in a standardized method provided the location, size and length of these notches are as indicated below.

1. Use minimum 2x4 #2 Grade or better.
2. Apply construction adhesive to entire contact surface of reinforcement.
3. Install reinforcement tight to the underside of the top flange opposite the side of the notch.
4. Attach with min 10d common, 2 rows, staggered and clinched @ 6" o.c. or #8 wood screws.
